Manhole Inspection Summary

Manhole # S17II2001MH

Insp Date: **10/4/06 11:04 AM**

Location Address: **5801 GREELY AVE**

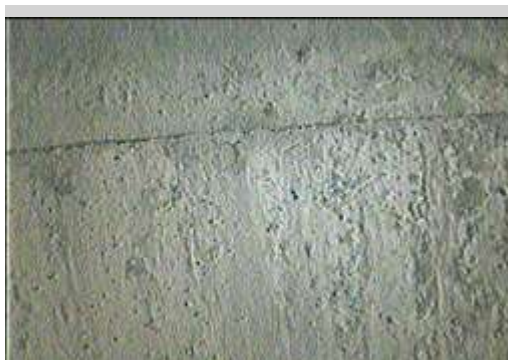
Defect

Infiltration: ☐ None ☒ **Joint** ☐ Cracks ☐ Mortar ☐ Roots ☐ Wall

Corbel and Barrel infiltration.

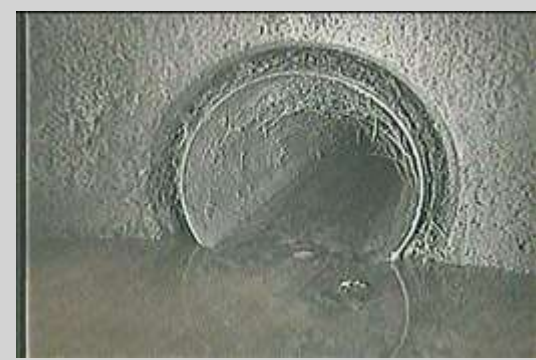
8 in. Circular Gravity Sewer Pipe Out @ 12 O'Clock

Deposits: ☐ None ☒ **Mud** ☐ Sludge ☒ **Debris** ☐ Grease

Silt Depth: **0** (in.) Deposits Extent: **Light**

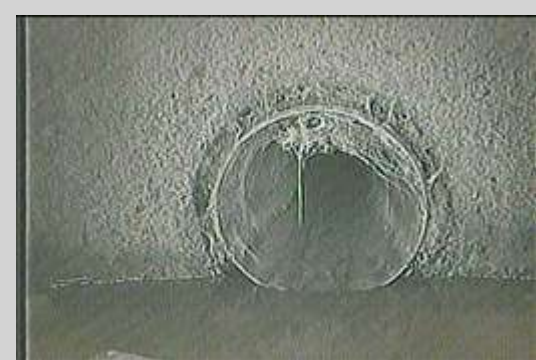
8 in. Circular Gravity Sewer Pipe In @ 5 O'Clock

Deposits: ☒ **None** ☐ Mud ☐ Sludge ☐ Debris ☐ Grease

Infiltration: **None** Pipe Seal Cond: **Unknown**
